**Flood Control Project Maintenance
Levee Inspections**
LMA District Cover Sheet
Spring 2018 Levee Inspection Results

Levee District No. 0001 (Sutter County)

Waterway			Bank	Unit Miles
Unit No. 01 Feather River			Right	16.11
	Spring (March - May)	Summer (June - August)	(September - November) Fall	Winter (December - February)
Unit Maintenance Rating (Fall Only)				
Date of Inspection	3/13/2018 - 3/13/2018			
DWR Inspector	Sterling York			
Accompanied By	Andrew Stresser LD0001S

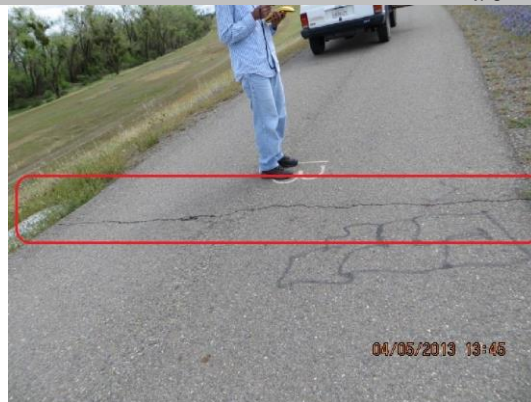
Photo 2 of 3 : UCIP_SP_2018_50675_19461.jpg

Levee crown overview- siphon breaker on right

Comment Code						
Inspector Comment						
FS_ID:50675 DS_ID:18879 EP_NO: N/A Repair Type: Non-Urgent Crossing Status: Not Found UCIP Comments: 07/20/2016 Pipe and pump station removed as part of the Feather River West Levee Project. (K. Fazel - UCIP)04/05/2013 Road pavement cracked along pipe line, needs more investigation. (P. Amatya - DWR) FIELD_STRUCT_DESC: *REMOVED* 2 of 2: 16-inch drainage discharge pipe of an unknown material through the levee, 6 feet below the crown. Flap gate on the waterside (WS) end. Siphon breaker in a corrugated metal pipe (CMP) riser on the WS shoulder. Pump house at the landside (LS) toe. [Additional Reference(s): DWR Levee Log, 2005, 24-inch pipe referenced]. FS Date: 7/20/2016
